THE MILESTONE REPORT

Fourth Quarter • 2003

AN INFORMATIVE NEWSLETTER ON RESTORATION AND PRESERVATION

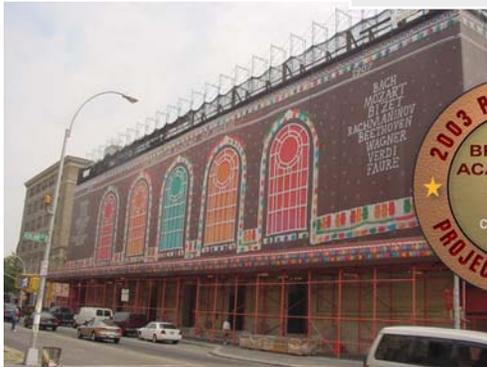
Brooklyn Academy of Music

PROJECT:	Brooklyn Academy of Music, Brooklyn, NY
CONSTRUCTION MANAGER:	Greyhawk North America
OWNER'S REPRESENTATIVE:	Macro Consultants
PRIME CONSULTANT:	Hardy Holzman Pfeiffer Associates LLP
RESTORATION CONSULTANTS:	Building Conservation Associates
DATE OF COMPLETION:	November 2003

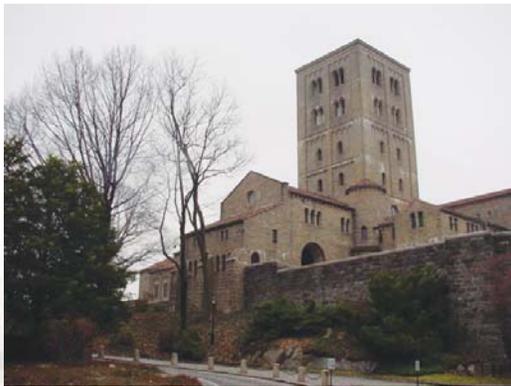
Due to its landmark status, renovation of The Cloisters requires strict adherence to preservation guidelines. Graciano's work at the facility will include replication and replacement of numerous Mission-style tiles, cleaning and

repointing of the building's granite facades, and probing of the structure's stonework to identify hidden structural problems. The company will also be responsible for resetting sections of the building's blue-stone and granite roof surfaces, and

will oversee the removal and reconstruction of a 70-year-old elevated stone walkway in the building's Fuentidueña Chapel area. Work at the site commenced the first week of September, 2003.

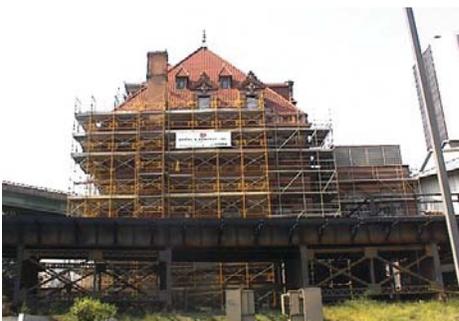
Main Street Station

PROJECT:	Main Street Station, Richmond, VA
OWNER:	City of Richmond, VA
GENERAL CONTRACTOR:	Daniel and Company
ARCHITECTS:	Gensler
CONSTRUCTION MANAGER:	URS
DATE OF COMPLETION:	2006

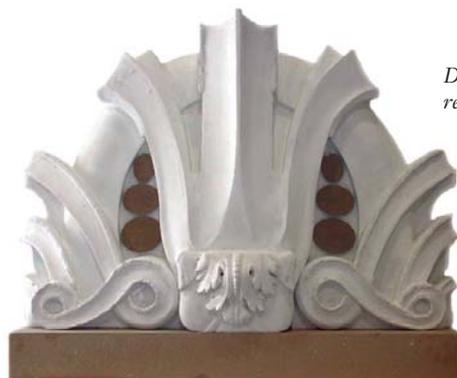
Detail of parapet replication

The project began at the base of the building’s roofline with reconstruction of four parapets – the largest of which had been removed from the building in the 1950s due to severe brick and terra-cotta damage. To replicate the look of the original structures, Graciano worked closely with BCA to ensure that these significant architectural elements were of the correct size and material composition. According to Ric Viera of BCA, “They realized the importance the missing and damaged parapets had to the original design, and truly understood how these features added height, color, shadows and general interest to the building.”
